# Customer Diagnostics Report

This sample document contains excerpts from a comprehensive diagnostics report. Contact your Experitec Account Manager to learn more about Diagnostics for your facility.

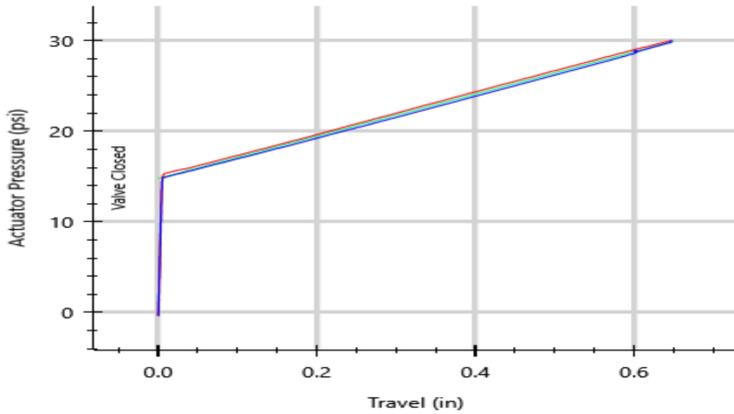
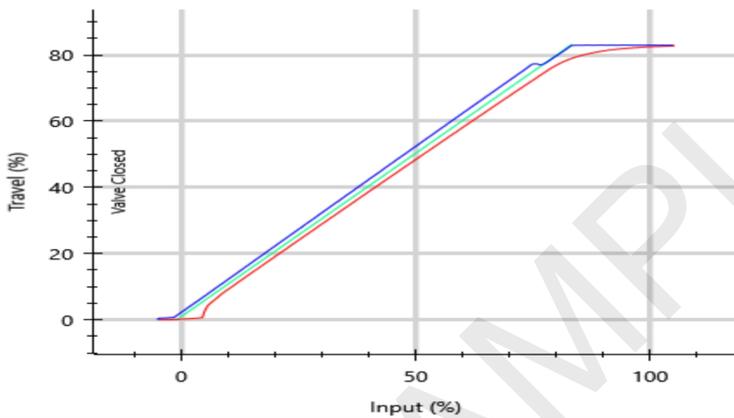
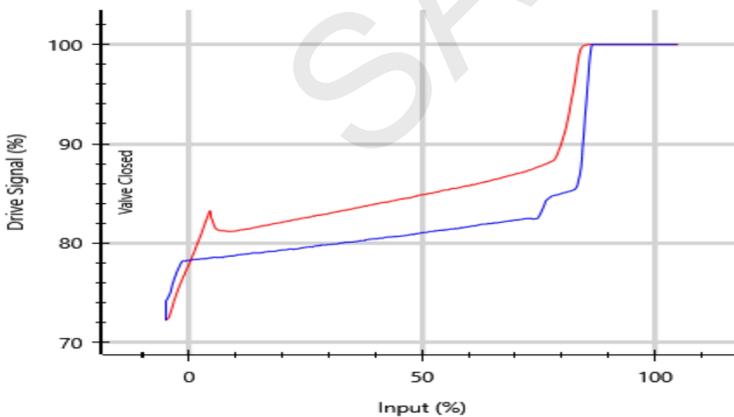
**Total Scan [STEAM]**

**Analyzed Data**  
 Avg. Dynamic Error: 3.76%  
 Min. Dynamic Error: 2.99%  
 Max. Dynamic Error: 4.80%  
 Dyn. Linearity (Ind.): 0.14%  
 Zero Ranged Travel at: 3.84 mA  
 Full Ranged Travel at: 20.05 mA  
 Average Friction: 28 lbf  
 Minimum Friction: 21 lbf  
 Maximum Friction: 32.13 lbf  
 Spring Rate: 2978.5 lbf/in  
 Bench Set: 14.79 - 32.96 psi  
 Seat Load As Tested: 1948.17 lbf  
 Service Seat Load: NA  
 Required Seat Load: 227.58 lbf  
 Expected Packing Friction: 60 lbf  
 Expected Total Friction: 60 lbf

Actuator is leaking air and the supply pressure appears to be low. Recommend rebuilding valve.
