Customer Diagnostics Report

1. SUMMARY OF VALVE PERFORMANCE

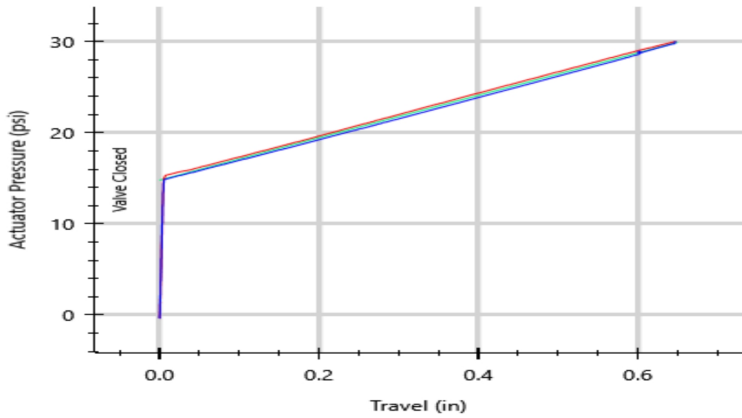
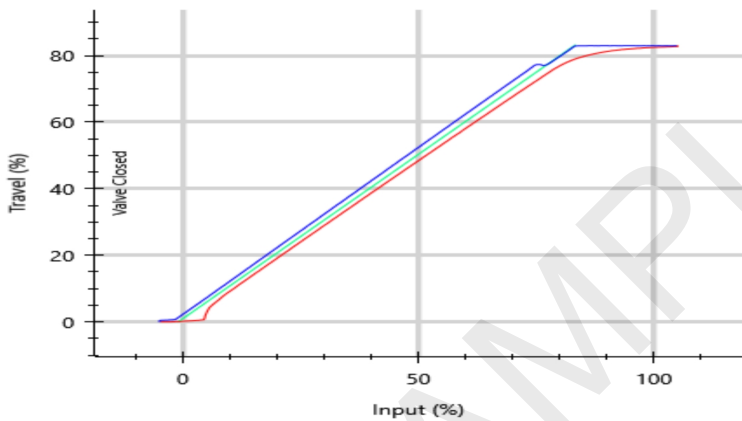
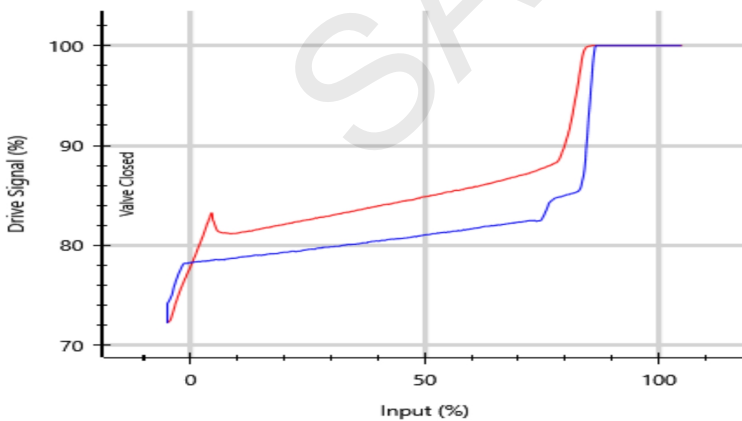
Total Scan [STEAM]

Analyzed Data
 Avg. Dynamic Error: 3.76%
 Min. Dynamic Error: 2.99%
 Max. Dynamic Error: 4.80%
 Dyn. Linearity (Ind.): 0.14%
 Zero Ranged Travel at: 3.84 mA
 Full Ranged Travel at: 20.05 mA
 Average Friction: 28 lbf
 Minimum Friction: 21 lbf
 Maximum Friction: 32.13 lbf
 Spring Rate: 2978.5 lbf/in
 Bench Set: 14.79 - 32.96 psi
 Seat Load As Tested: 1948.17 lbf
 Service Seat Load: NA
 Required Seat Load: 227.58 lbf
 Expected Packing Friction: 60 lbf
 Expected Total Friction: 60 lbf

Actuator is leaking air and the supply pressure appears to be low. Recommend rebuilding valve.
